## **Show Dome Façade Study**

**Milwaukee County - Mitchell Park Domes**

## **LOWER LEVEL FAÇADE REVIEW**

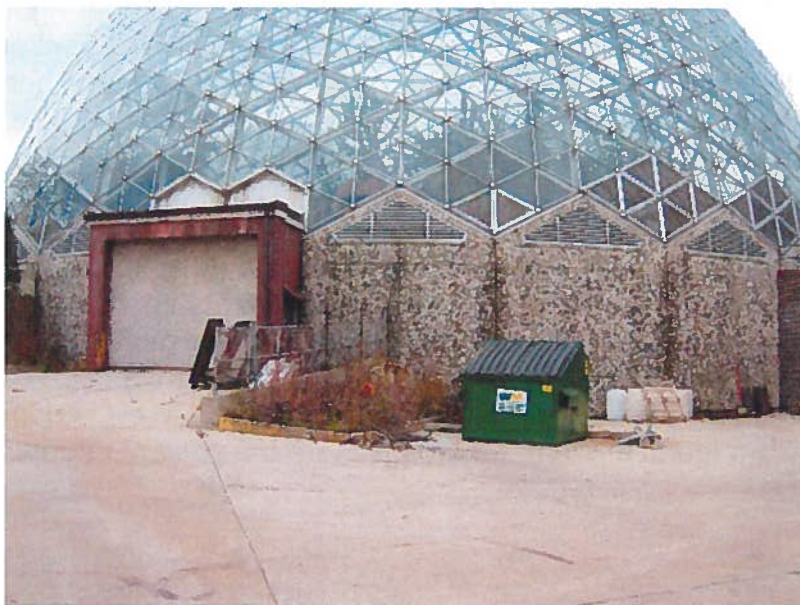
**Figure 18:** North Wall of Arid Dome

The northeast quadrant of the Arid Dome has an exposed foundation wall. This wall is clad with cobble-faced precast concrete panels to match the exterior precast concrete panels used around the base of the three main domes. A review of the original construction plans and a visual inspection were performed to determine the condition of this façade. Based on these reviews, a portion of a joint between panels was removed to verify the construction, and to determine the type and condition of the panel anchors.

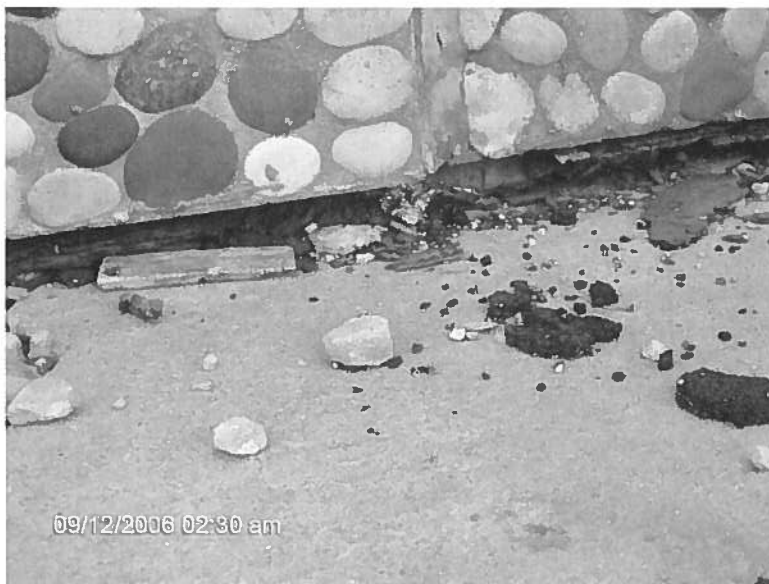
**Figure 19: Severely Corroded Panel Support Angle**

The base angle of the left panel is tight to the concrete slab at this section. The base angle is severely corroded. There is a 2-foot long concrete spall at the base of this panel. The base angle at the right panel is severely corroded. The gap between the pavement and the base angle increases to the right. The sealant covering the mortar joints between panels is in good condition.

Trapped moisture in the cavity behind the precast panels, from condensation and salt-laden snow on the exterior, has corroded the base angles. The rust expansion of the angles has caused the spalling at the bottom of several wall panels. The continued loss of material from the support angles can eventually lead to the panels falling off the building.

- 2) The panel cracks should be routed and sealed to prevent water intrusion.
- 3) The deteriorated base angles should be replaced with galvanized steel angles. Removal of the pavement below and in front of the panels will be required to install the new angles. Reconfiguration of the pavement will be required to provide a drainage space below the base angles.

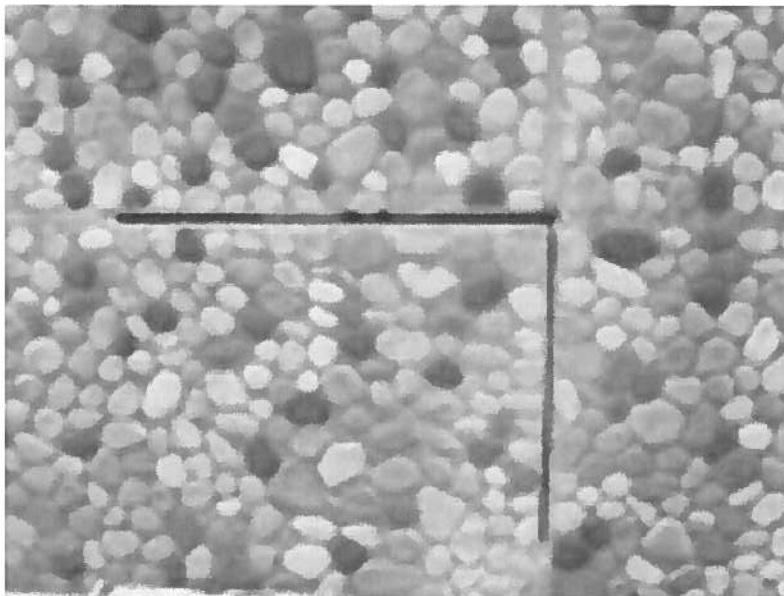
**Figure 20:** Exploratory Investigation at Section A3

A 30-inch long section of sealant and mortar joint was removed from a horizontal and vertical joint at the center of Section A3. The precast concrete panel was measured to be 2 1/2 inches thick. The cavity behind the panel is 1 1/2 inches wide and is not filled with grout. The panels have a continuous shallow groove cast into the top and bottom edges. Six inch long pieces of steel angle, with a 2 1/2 inch outstanding leg, are used to tie the panels to the concrete foundation walls. A piece of 3/8-inch diameter rod is welded to the top and bottom, at the tip of the angle, to capture the groove in the precast panels. The connection angles are located 18 inches from the ends of the panels. The angle inspected had surface rust without any loss of section. It is assumed that there are three connection angles per panel. The fastening of the connection angles to the wall could not be verified. The fasteners of the base support angles cannot be verified without removal of the wall panels.

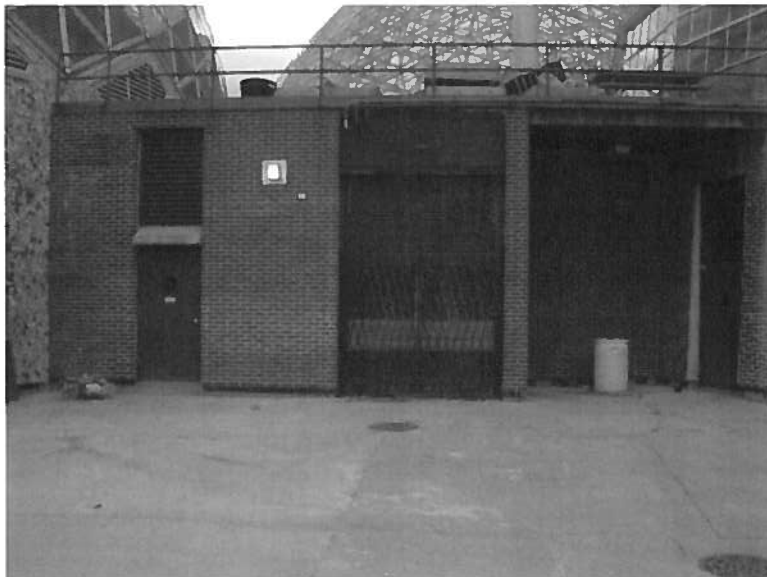
**Figure 21:** Exterior Wall at Mechanical Room

A review of the original construction plans and a visual inspection were performed to determine the condition of the façade. Based on these reviews, two locations were selected for removal of the brick for inspection openings. The openings were created to determine the conditions of the façade, foundation wall, and façade anchors at these locations.

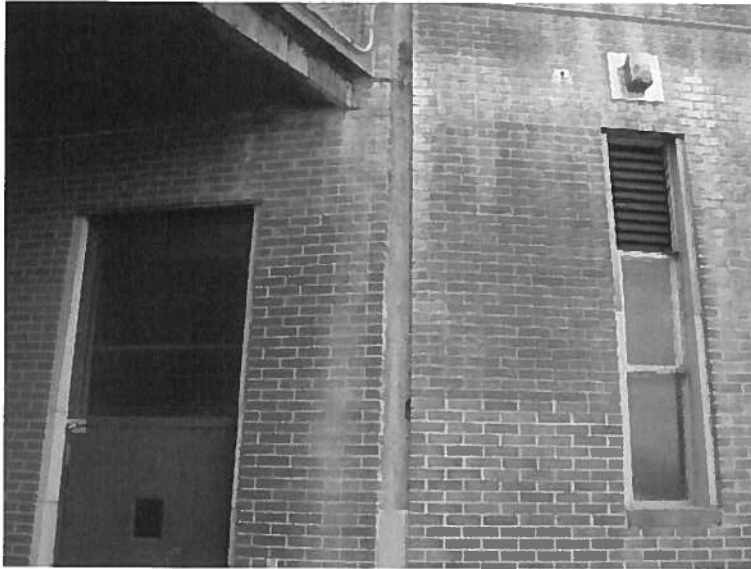
**Figure 23:** Missing Precast Concrete Corner Trim

The support angle at the base of the brick veneer has been replaced with a 4 x 4 x ¼-inch angle with ½-inch diameter anchors at approximately 32 inches on center. The upper sections of the precast corner trim on the left side of this section are missing. (See Figure 23). A 3/8 to ½-inch gap is visible at this location between the original grout fill and the concrete wall. A 3 x 4 x ¼-inch intermediate shelf angle is visible on both sides of this exposed corner. The joint in front of the outstanding leg is filled with mortar. There is no flashing at this intermediate support. The anchors for these members are not visible. The upper sections of the precast window trim are cracked with small spalls.

The precast concrete jambs and corner elements were poorly connected to the structure. The porous nature of this material allows moisture to penetrate the surface. The subsequent corrosion of the reinforcing steel causes the cracks and eventual spalling. Since no expansion or control joints were provided, thermal forces have pushed the corner elements away from the concrete wall and cracked the mortar joints at the window trim elements.

To protect the occupants and suppliers using this portion of the building, it is recommended that all loose pieces around the man doors and overhead doors be identified and removed as soon as possible.

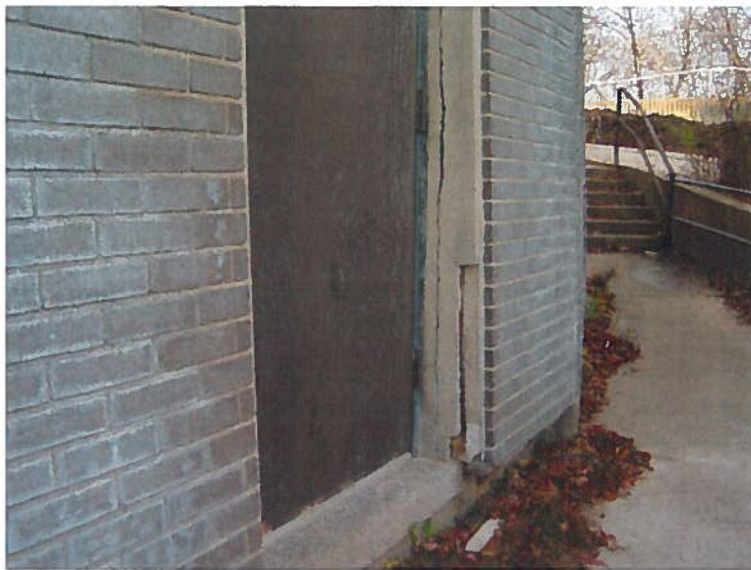
**Figure 24: Failed Precast Concrete Door Trim**

These sections are supported on a concrete ledge. Weep holes,  $\frac{3}{8}$  inches in diameter, are provided at 24 inches on center. These weeps are plugged with mortar approximately  $\frac{3}{4}$  inches in. The window precast concrete jambs on Section B9 have hairline cracks and the mortar joint to the brick facing is cracked. The jambs at Section B10 are severely cracked and spalled. (See Figure 24). There is a horizontal crack in the mortar joint left of the window head at Section B10. The precast corner trim between these sections has several hairline cracks.

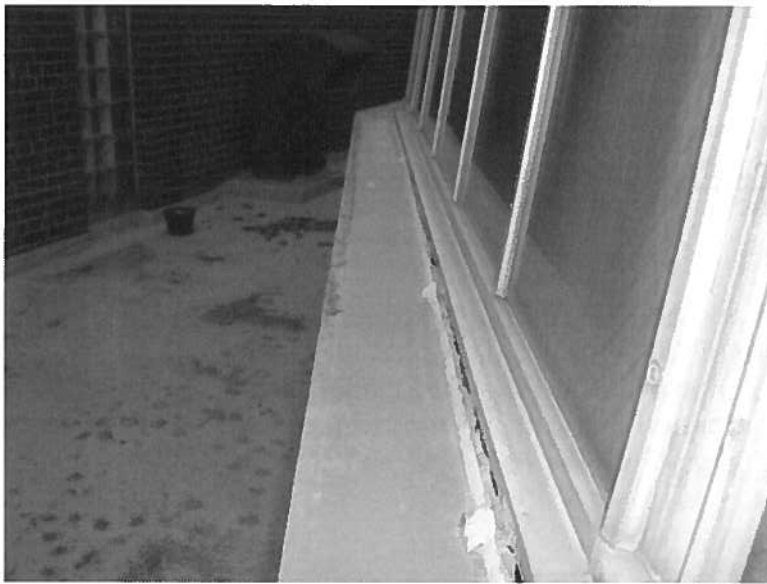
**Figure 25:** Top of Wall Flashing at Breast Wall

The brick façade on the southwest quadrant breast walls appear to have been built on a concrete ledge. The precast corners between panels are cracked or spalled. The gaps in the top flashing indicate the brick facing has moved up to a 1/2 inch away from the concrete backup wall. (See Figure 25).

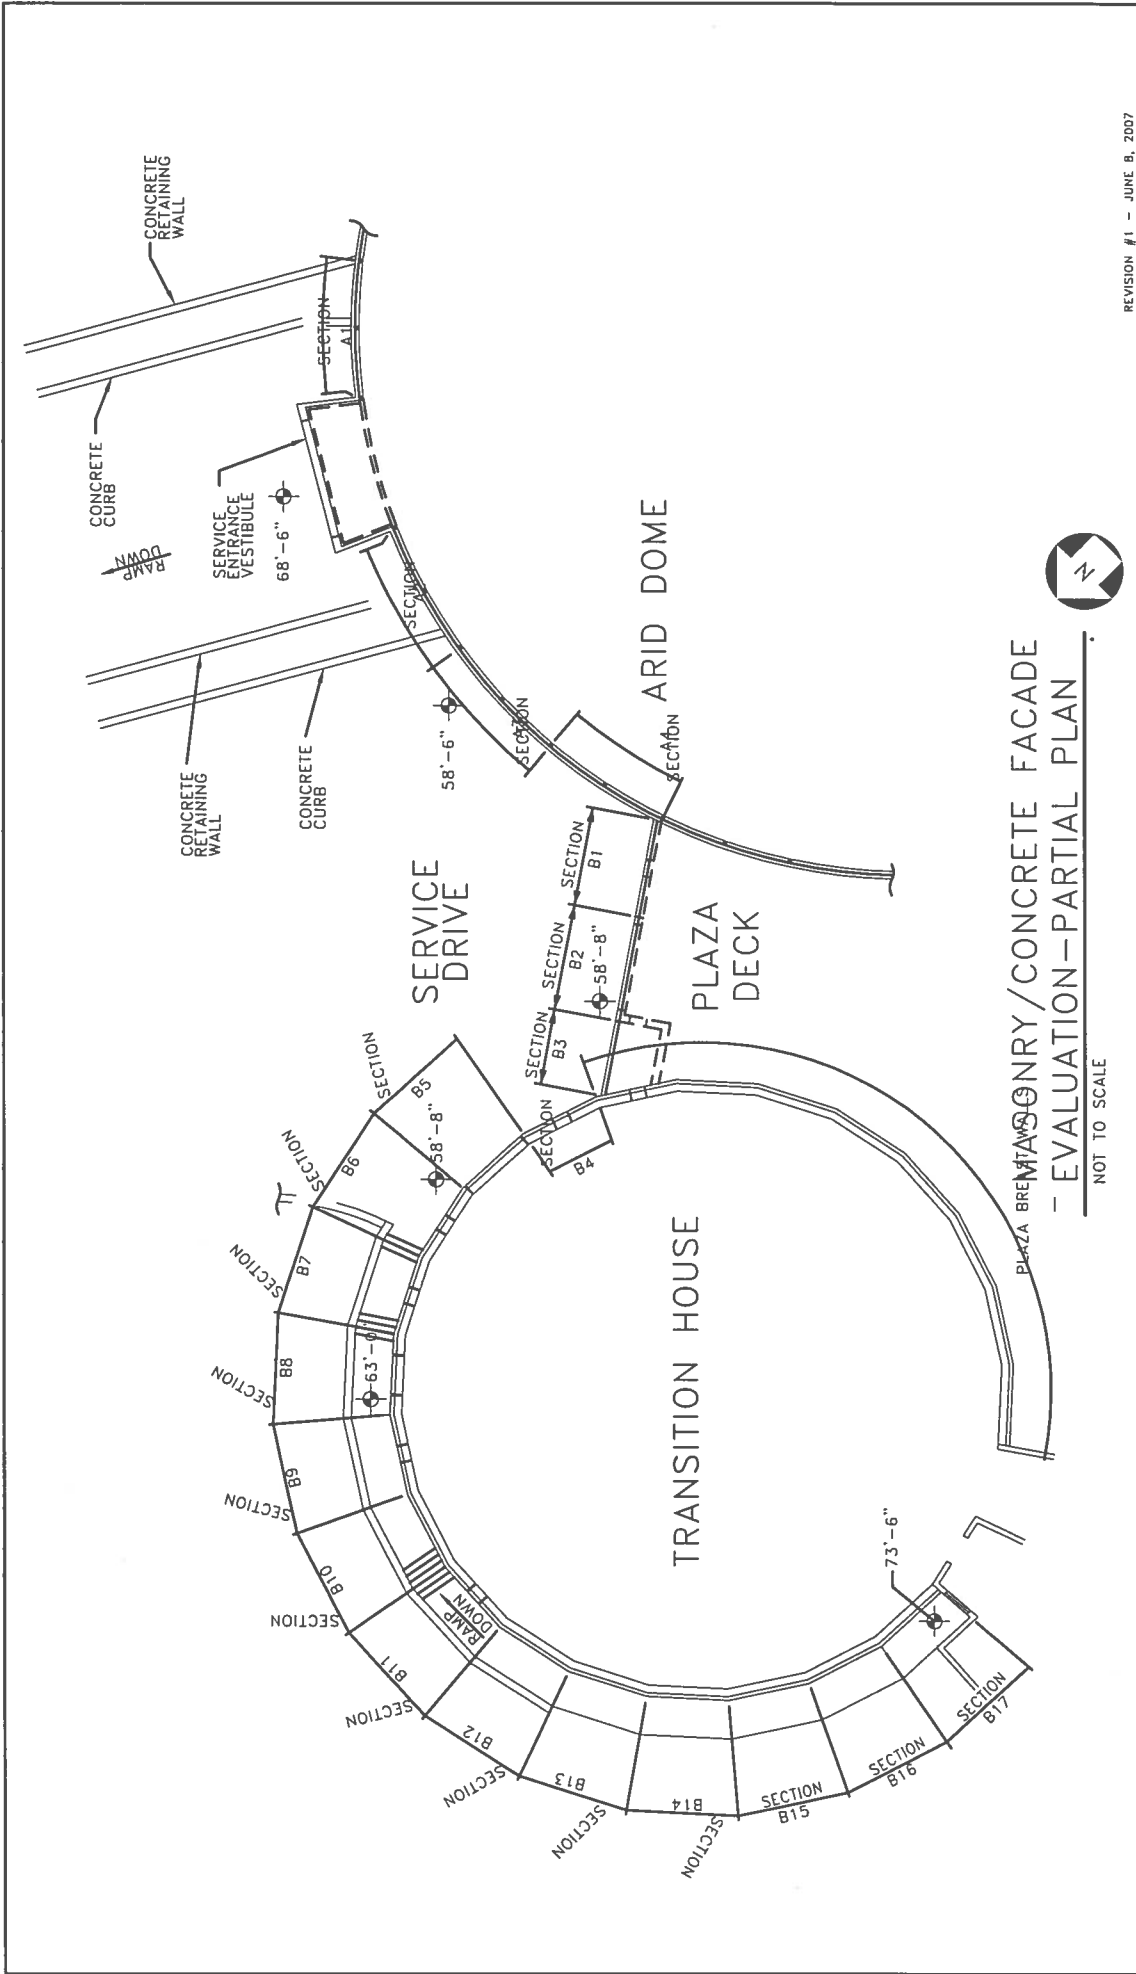
# MASONRY/CONCRETE FACADE - EVALUATION-PARTIAL PLAN

The existing precast panel installation varies considerably from the building plans. The panels are installed as two stacked pieces rather than one continuous vertical piece. The thickness of the precast panels is approximately 2 ½ inches. The continuous base angle has a 4-inch horizontal leg. There are no weep holes or flashings visible at the base of the panels. Repairs have been made to reinforce or replace the bottom angle at some locations. The façade was divided into sections, comprised of two vertical panels each, to document the varying conditions and deterioration found. The wall sections, as noted below, are diagrammed on Exhibits SD-14 and SD-15 in Appendix A.

The façade appears to have been built as indicated on the plans and sections. Significant deterioration of the precast stone elements was noted. The inspection surface was divided into sections, generally between doors or corners, to note the varying conditions and the deterioration found. The wall sections, as noted below, are diagrammed on Exhibits SD-14 and SD-15 in Appendix A.
